HOME INSPECTION REPORT

XYZ

Apr 15 2023

000000

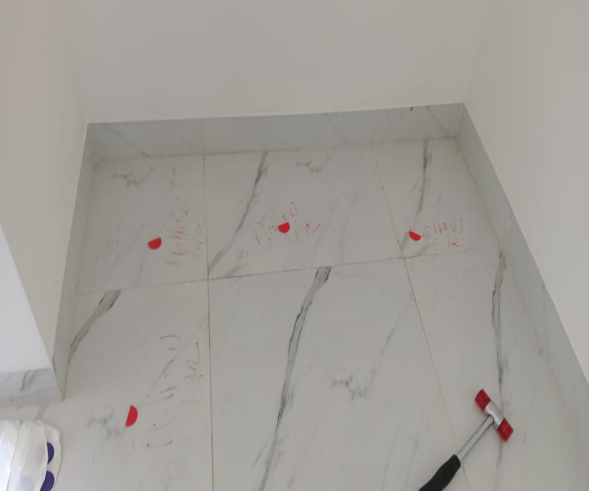
S. NO.	ISSUE	PICTURE
1	Floor tiles sounding hollow.

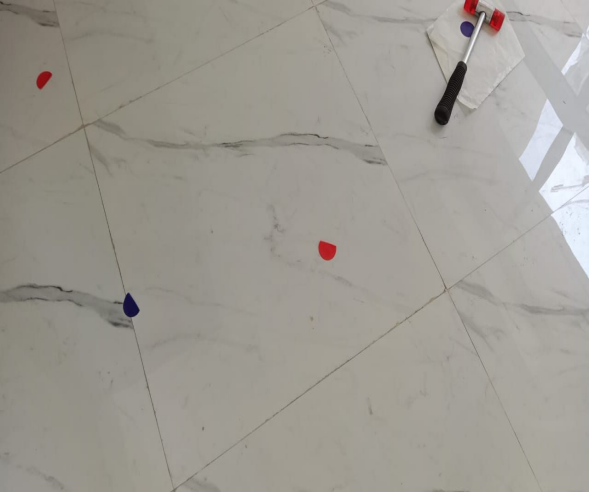
2	Shade variation observed on flooring.

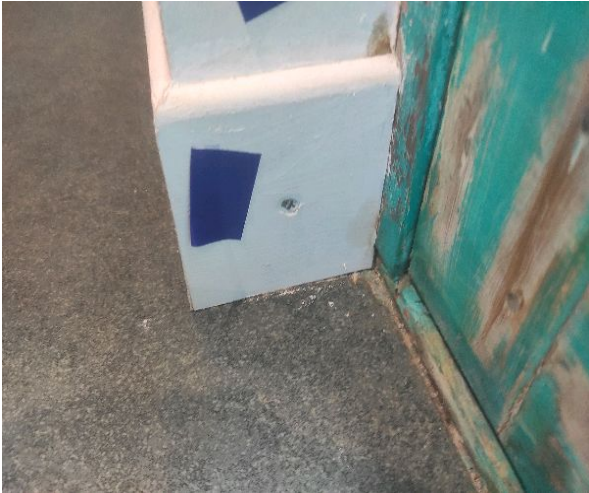
3	Screw protruding from skirting.

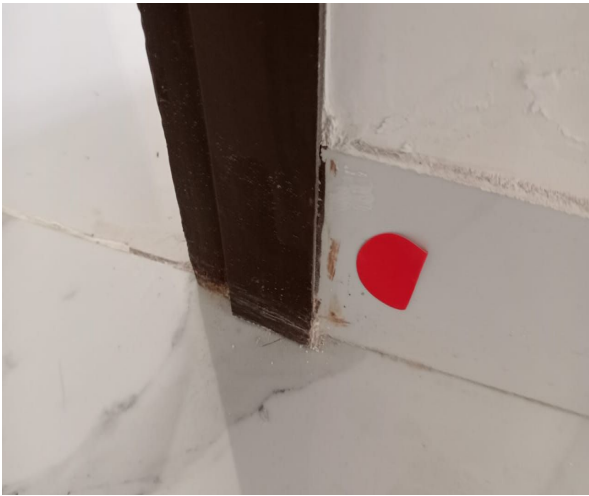
S. NO.	ISSUE	PICTURE
4	Sealant application not done properly so gap observed between frame and shutter.

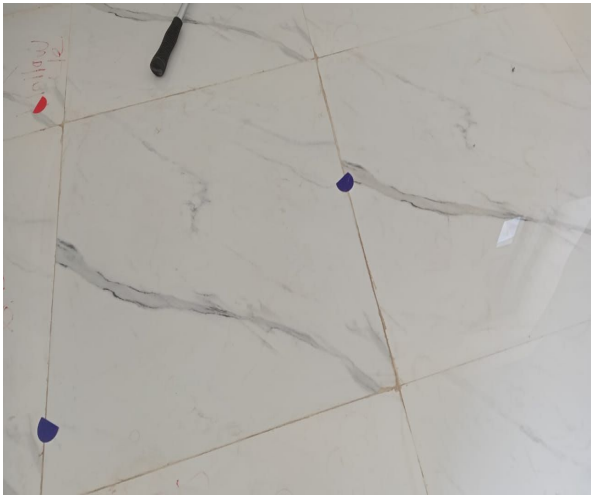
5	Offset observed on floor tiles.

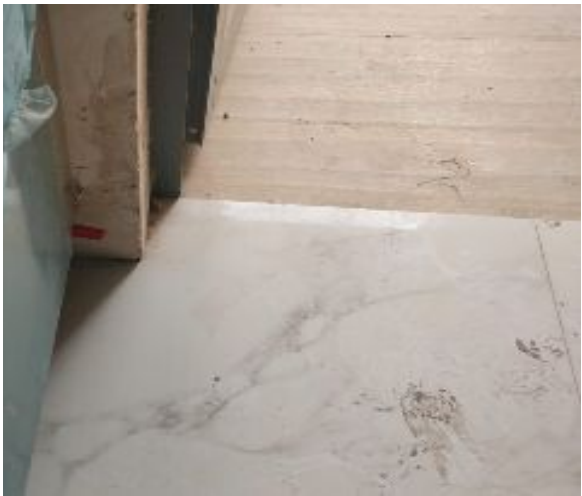
6	Cracks / damages observed on flooring

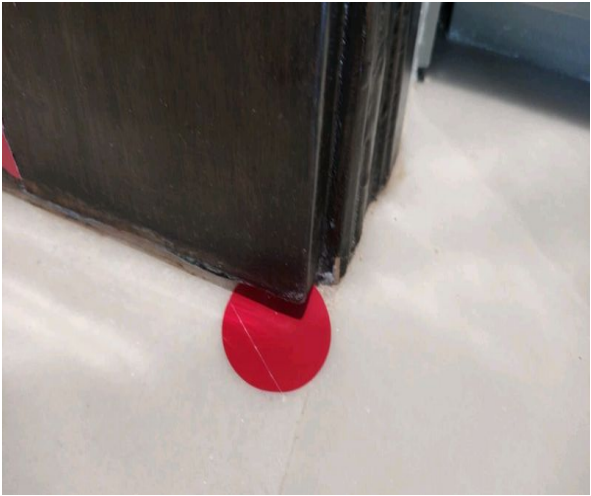
S. NO.	ISSUE	PICTURE
7	Gap observed between floor and door frame

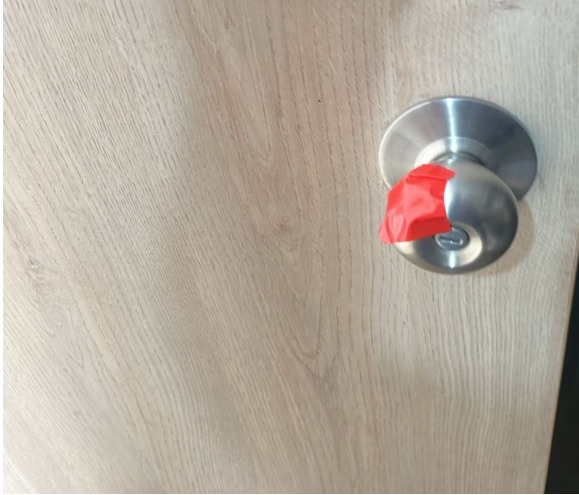
S. NO.	ISSUE	PICTURE
1	Shutter lock not working

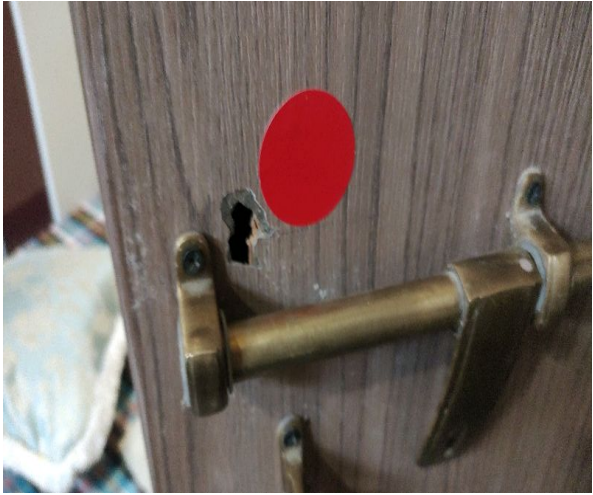
2	Damage observed in door shutter

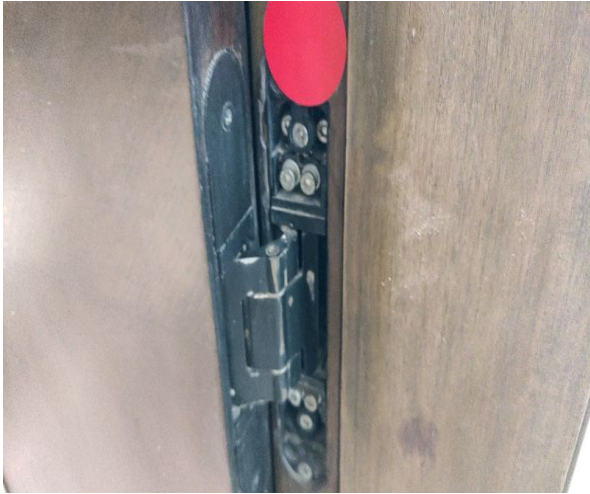
3	Screws missing in door hindge

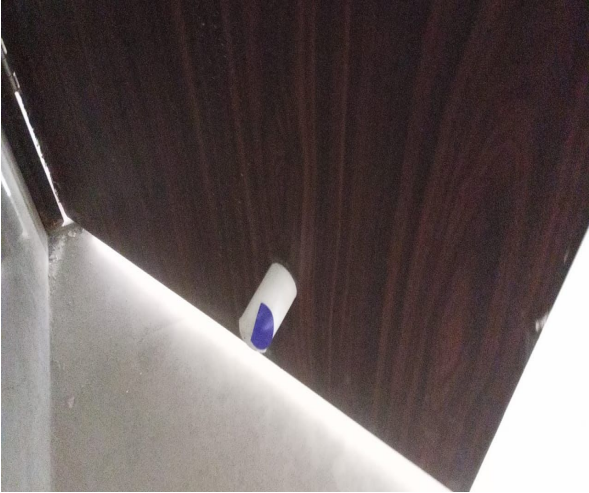
S. NO.	ISSUE	PICTURE
4	Door buffer not screwed properly

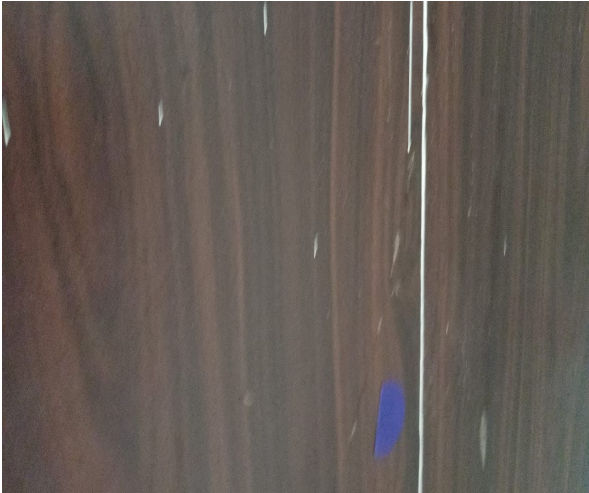
5	Paint stains observed on shutter

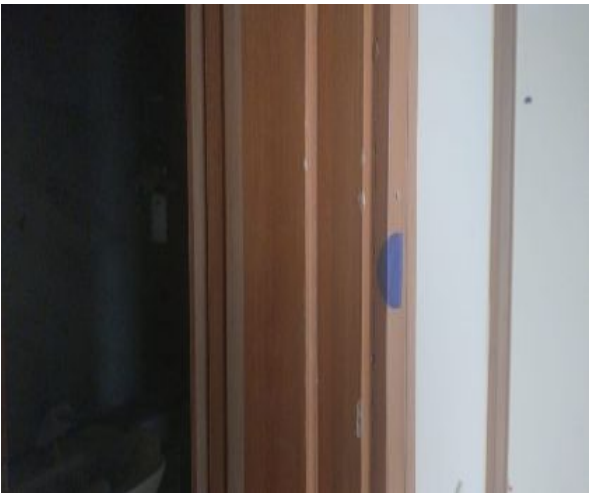
6	Gap observed between cover moulding Patti and door frame.

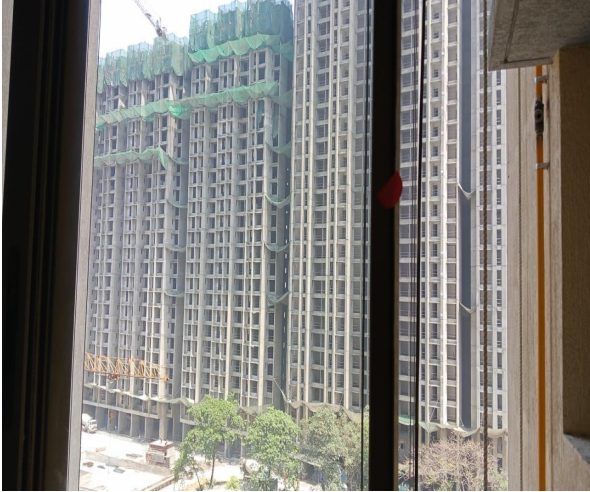
S. NO.	ISSUE	PICTURE
1	Shutter not operating smoothly

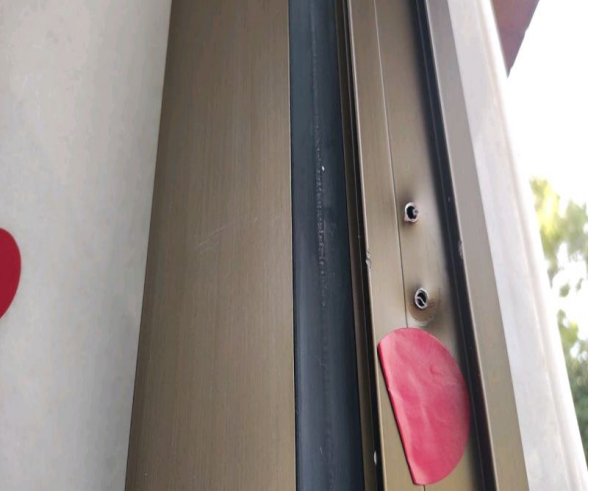
2	Holes observed in window frame

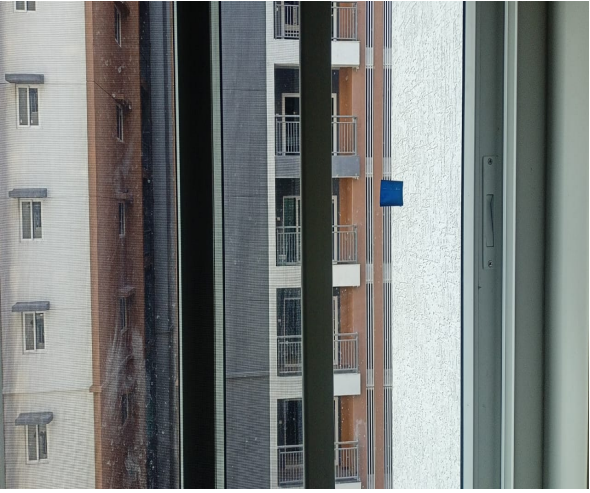
3	Scratches observed on glass

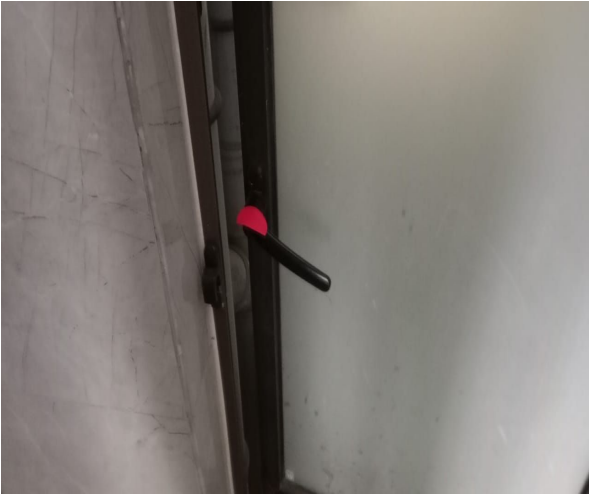
S. NO.	ISSUE	PICTURE
4	Gap observed between window frame and wall

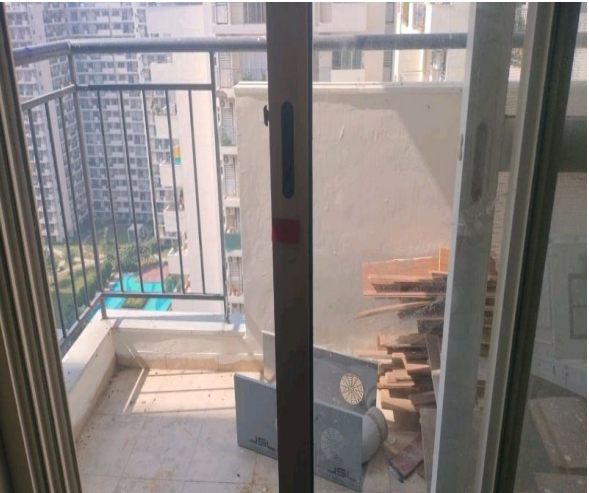
5	Window lockset not working properly.

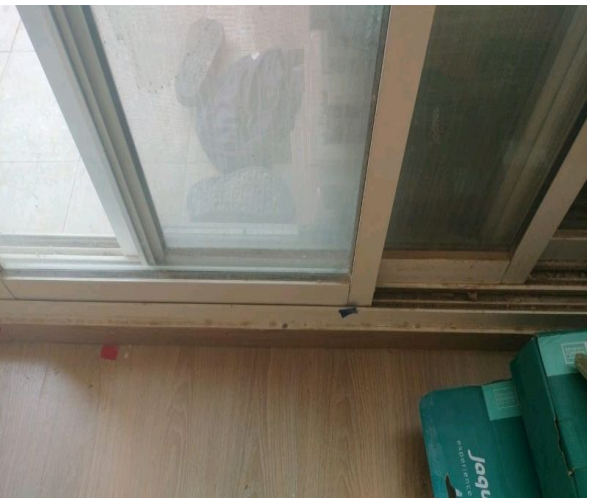
6	Paint stains observed on window frame.

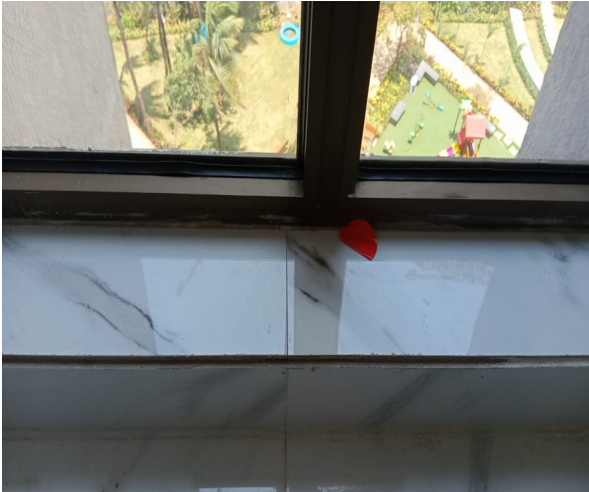
S. NO.	ISSUE	PICTURE
7	Gaps between frame and wall opening are not sealed with sealant from internal side.

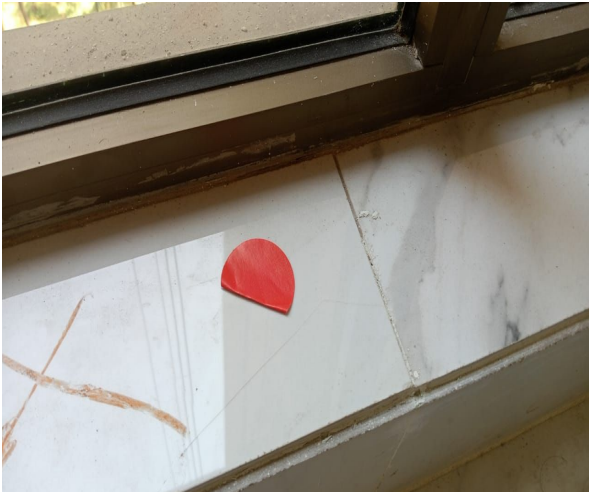
8	Crack observed on window sill tile.

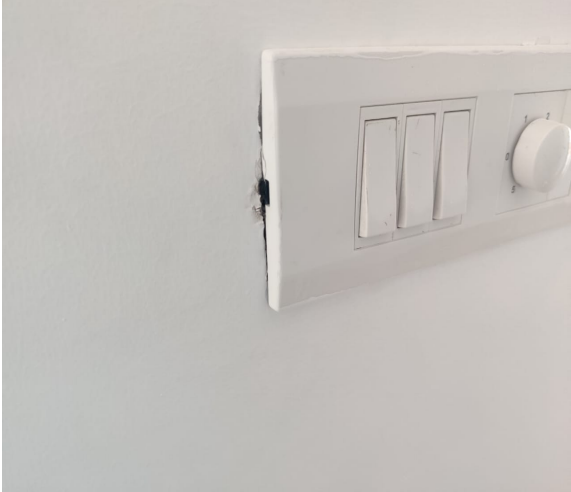
S. NO.	ISSUE	PICTURE
1	Gap observed between wall surface and Switch board

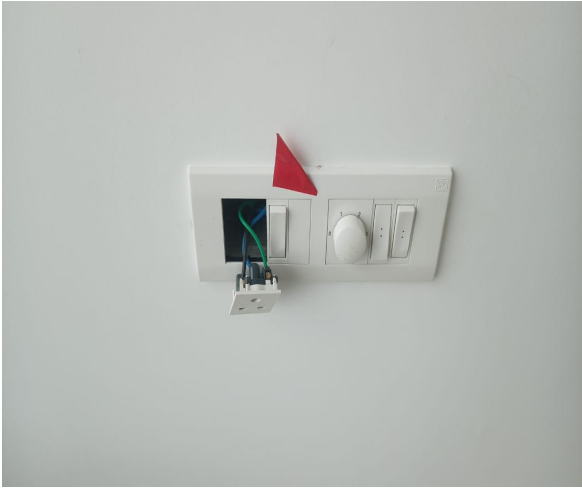
2	Socket not fixed properly

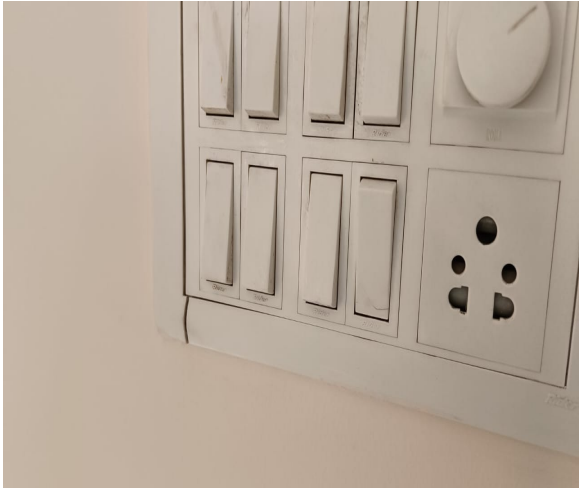
3	Damage observed on switch plate

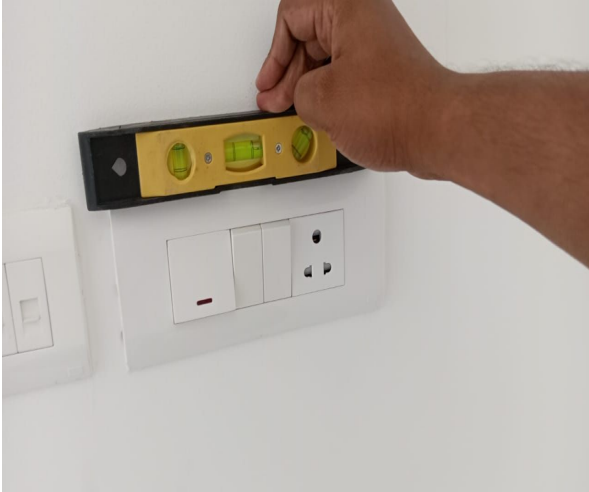
S. NO.	ISSUE	PICTURE
4	Switch plate not fixed in line and level.

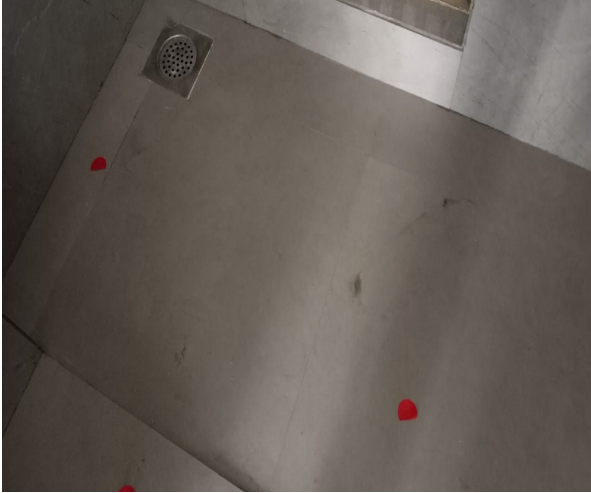
S. NO.	ISSUE	PICTURE
1	Adequate slope not provided

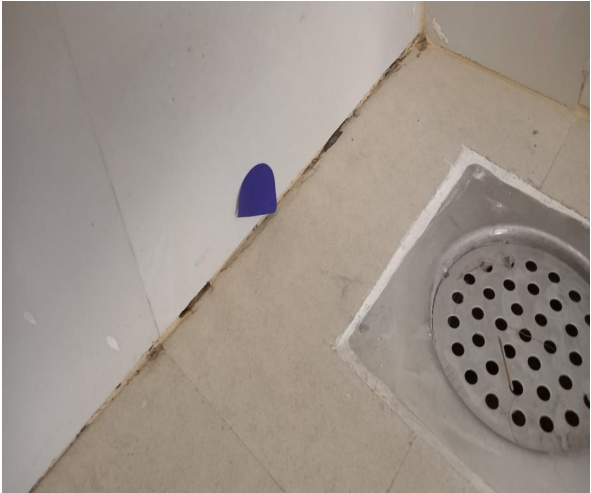
2	Grouting not done properly between wall and flooring tile

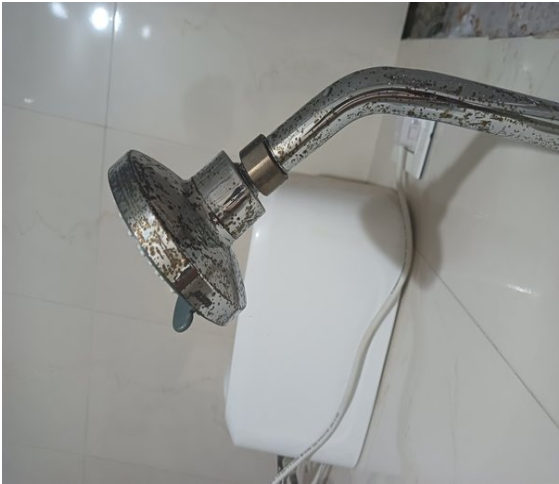
S. NO.	ISSUE	PICTURE
4	Rusting observed on shower head

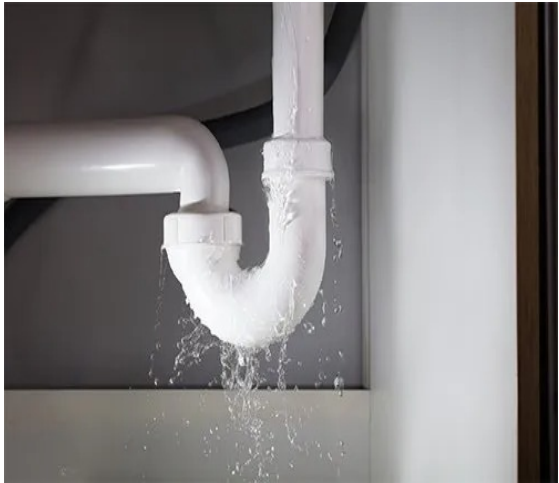
5	Leakage observed below wash basin

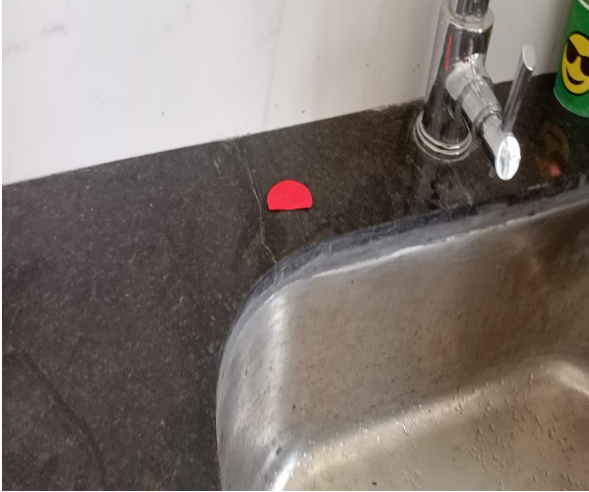
S. NO.	ISSUE	PICTURE
1	Cracks observed on granite stone.

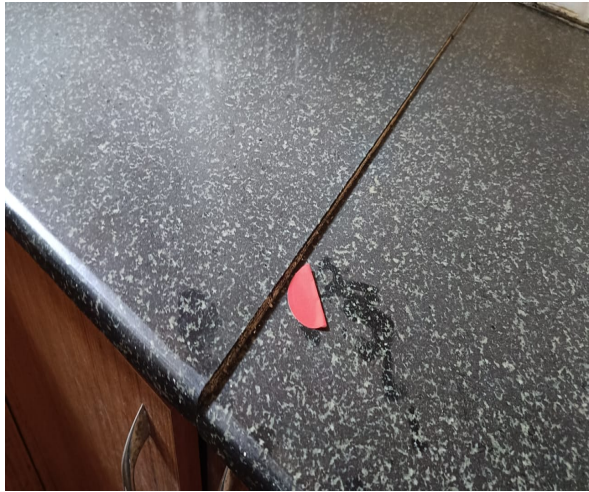
2	Granite not fixed in uniform level

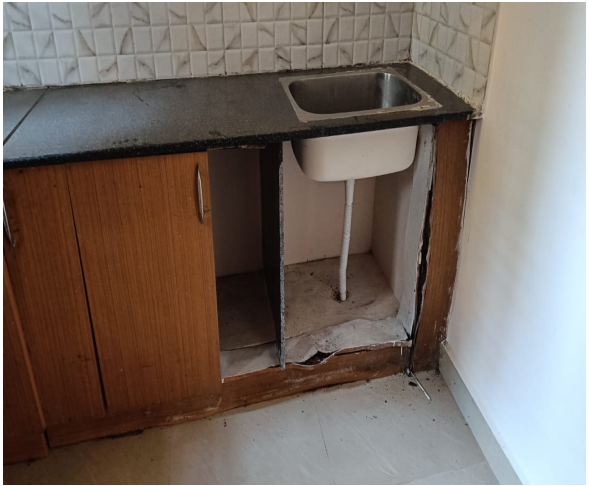
3	Damage observed in kitchen modular.
